SOMALIA, JILIB DISTRICT STATUS OF RIVER BREAKAGES **RIVER JUBA - AUGUST 2021**

Map Reference: SOM_WAT_JILIB_JUBA_RIVER_ BREAKAGES_SWALIM_25082021_A3

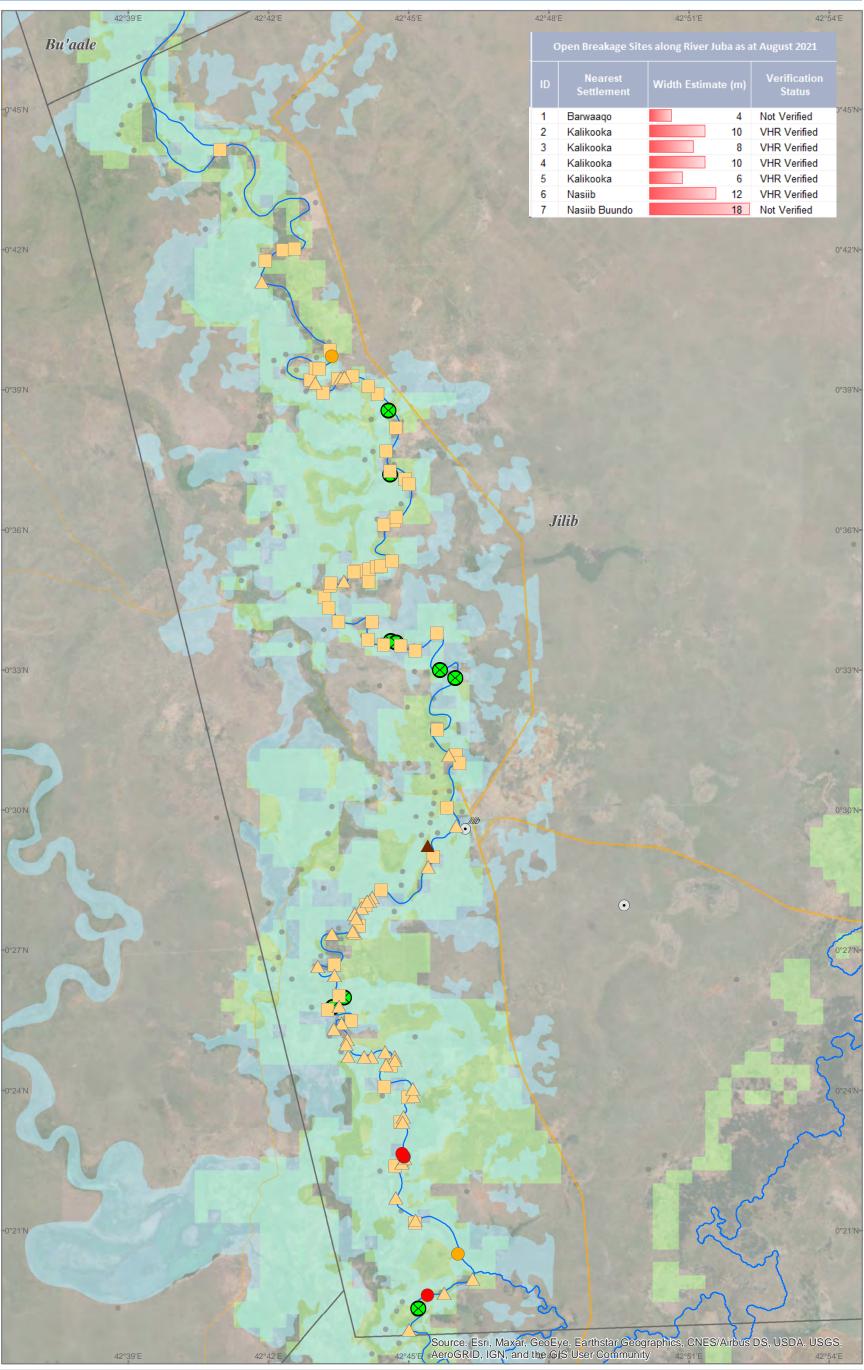
Verified Breakage: Confirmed this season through VHR Images and/ Field Verification

Not Verified Breakage: Confirmed in previous season but there was either cloudy or no VHR Image for assessment this season

Satellite data: WV2/WV3 Imagery dates: Mar 2019 - Aug 2021 Imagery resolution: 0.3 - 0.5 Meter Imagery source: Digital Globe, Airbus Other dataset: FAO-SWALIM,UNDP Analysis: FAO-SWALIM Map projection: Geographic Datum: WGS 84
